**BOEING AIRPLANE COMPANY**  
**WICHITA, KANSAS**

DOCUMENT NO. WD-14018 DATE January 31, 1956

MODEL BC-47E CONTRACT NO. 5148

TITLE ANALYSIS OF WFT-709 FLIGHT TESTS OF NAVIGATOR'S  
COMPARTMENT DEFROSTING SYSTEM

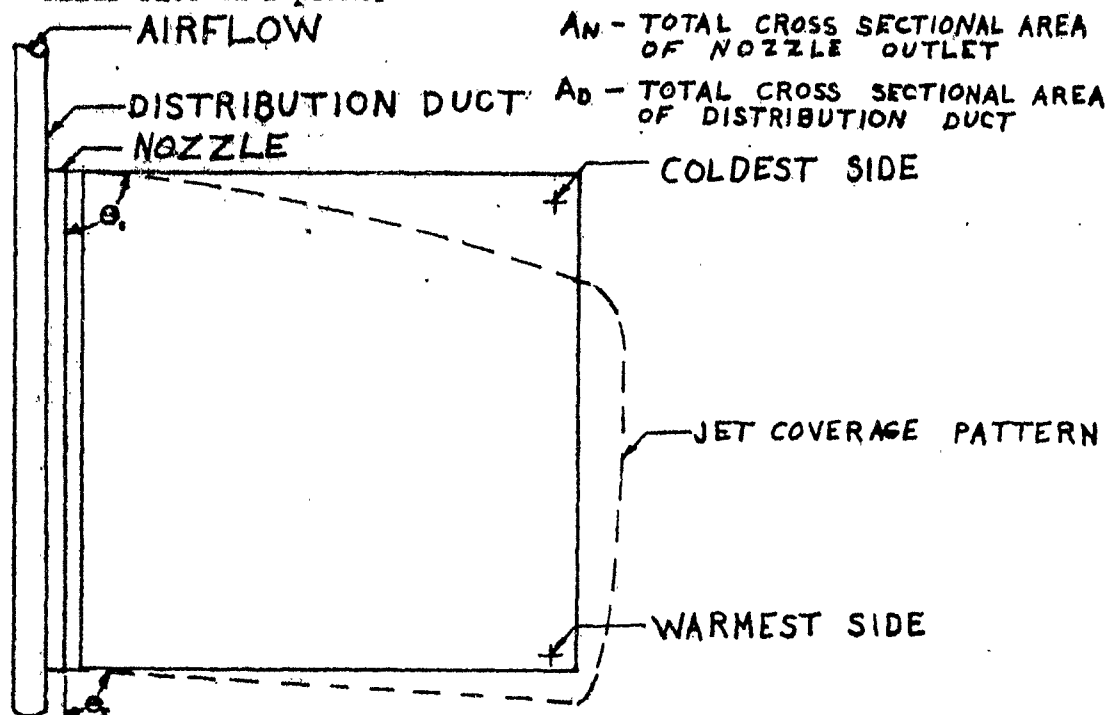
as the temperature variation is concerned. The following sketch will illustrate this point:

The pattern of airflow coverage, or more specifically, the angle  $\theta_1$  and  $\theta_2$ , is a function of the ratio  $A_n/A_d$ . A numerical increase of this ratio will decrease the angles  $\theta_1$  and  $\theta_2$  and narrow the jet coverage pattern while a decrease in the ratio will widen the jet coverage pattern and consequently provide more uniform surface temperatures. The ultimate in coverage would be obtained when the angles  $\theta_1$  and  $\theta_2$  are  $90^\circ$ . The above is based on informal laboratory tests of a continuous slotted outlet nozzle but the results are believed applicable to an orifice type outlet nozzle, which is the type used in the defrost system. To obtain optimum airflow coverage, the total area of the orifices should only be about 25% of the cross sectional area of the supply duct. Of course, a small size orifice will increase the system pressure drop and the improvement in window coverage may have to be weighed against the affect of increased pressure drop on the upstream components, especially the blower.

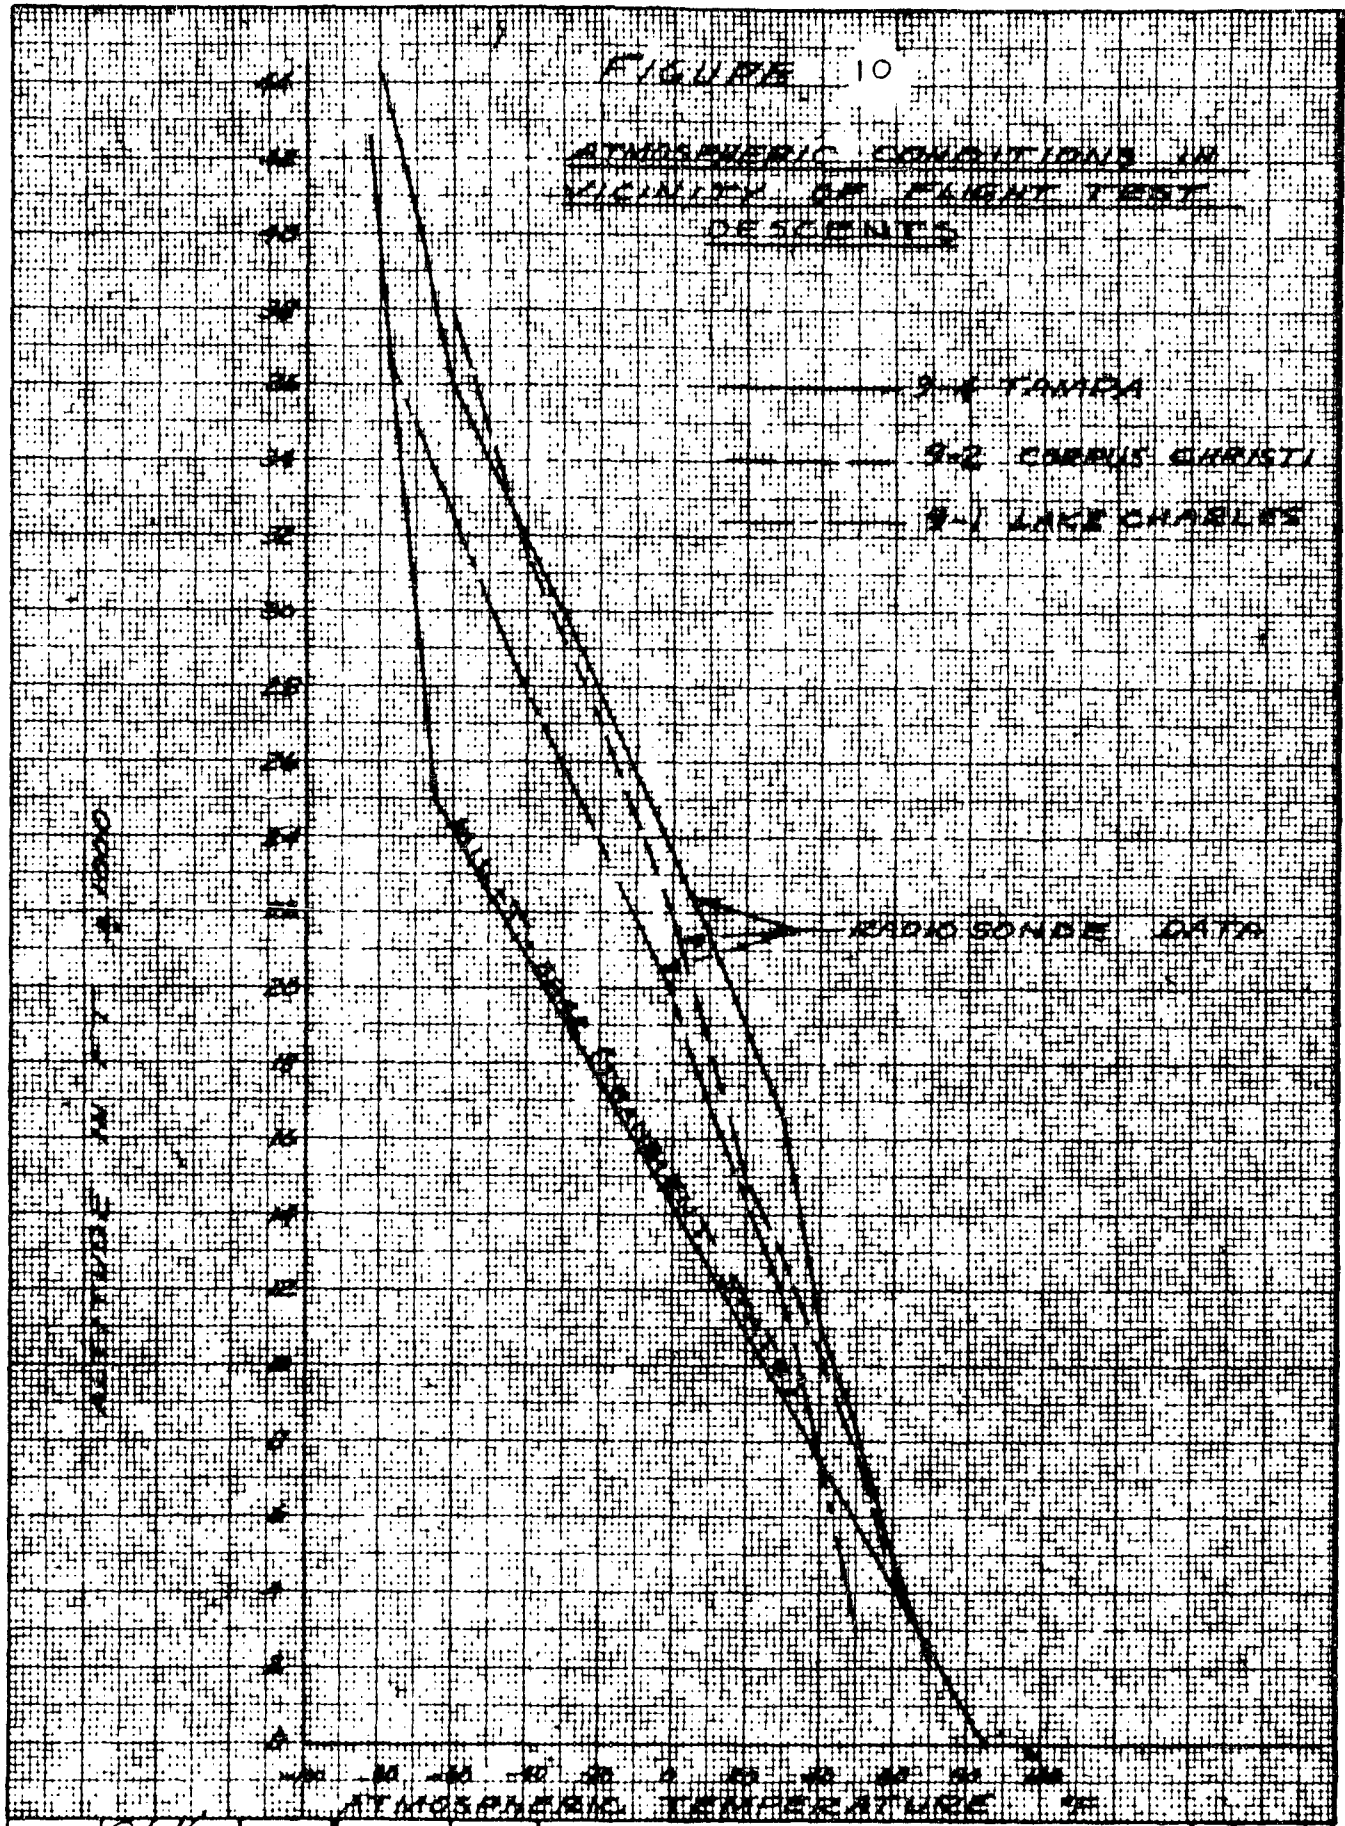
FIGURE  
10

ATMOSPHERIC CONDITIONS IN  
VICINITY OF FLIGHT TEST  
DESCENTS

ATMOSPHERIC CONDITIONS IN VICINITY OF  
FLIGHT TEST DESCENTS

Ambient temperature and relative humidity variation with altitude at Lake Charles is shown in Figure 4. The ambient temperature variation, as compared to a design day per MIL-T-5842A, is shown in Figure 10. This information is based on radiosonde data from the USAF Weather Station at Lake Charles, Louisiana.

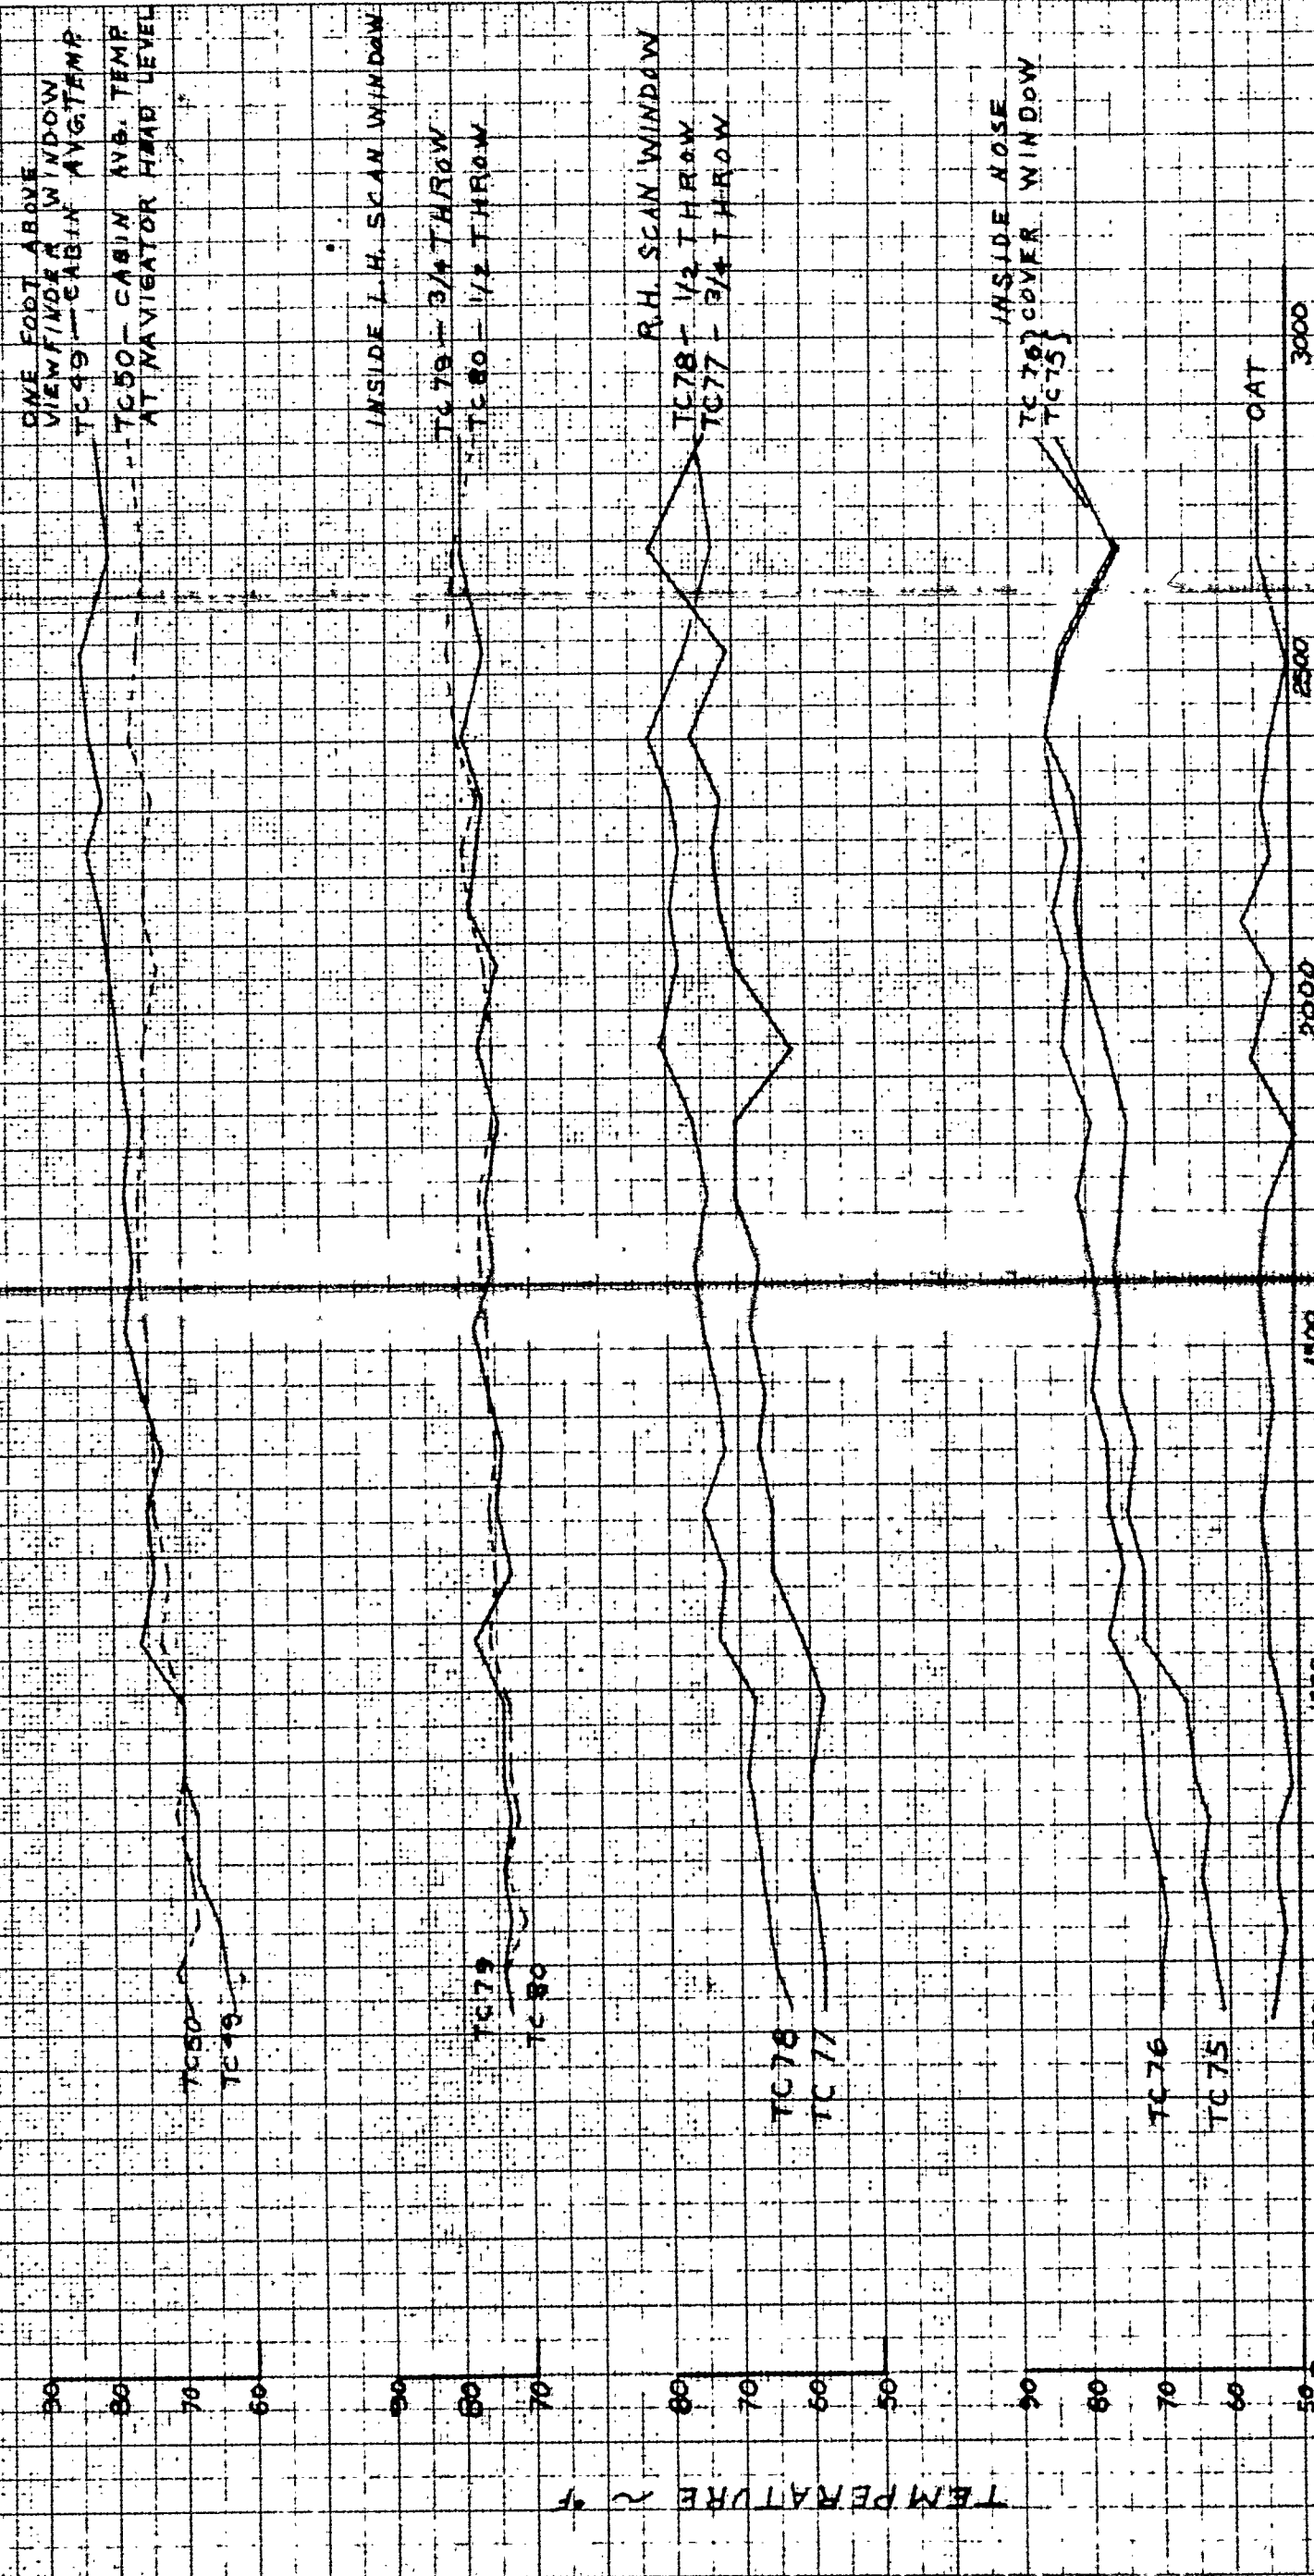
# NOSE COVER AND SCAN WINDOW INSIDE SURFACE TEMPERATURE DURING GROUND TEST 3-4

CALC. N. DECHT. 10-5-54		REVISOR DATE	NAVIGATOR'S COMPARTMENT DERUSTING SYSTEM PER FORNANCE WINDOW INSIDE SURFACE TEMPERATURES - GROUND TEST 3-4	FIG. 11a
CHECK	APR 10-11-54			
APR				BB-474
APR				WD-11018
BOEING AIRPLANE COMPANY WICHITA, KANSAS			PAGE 61

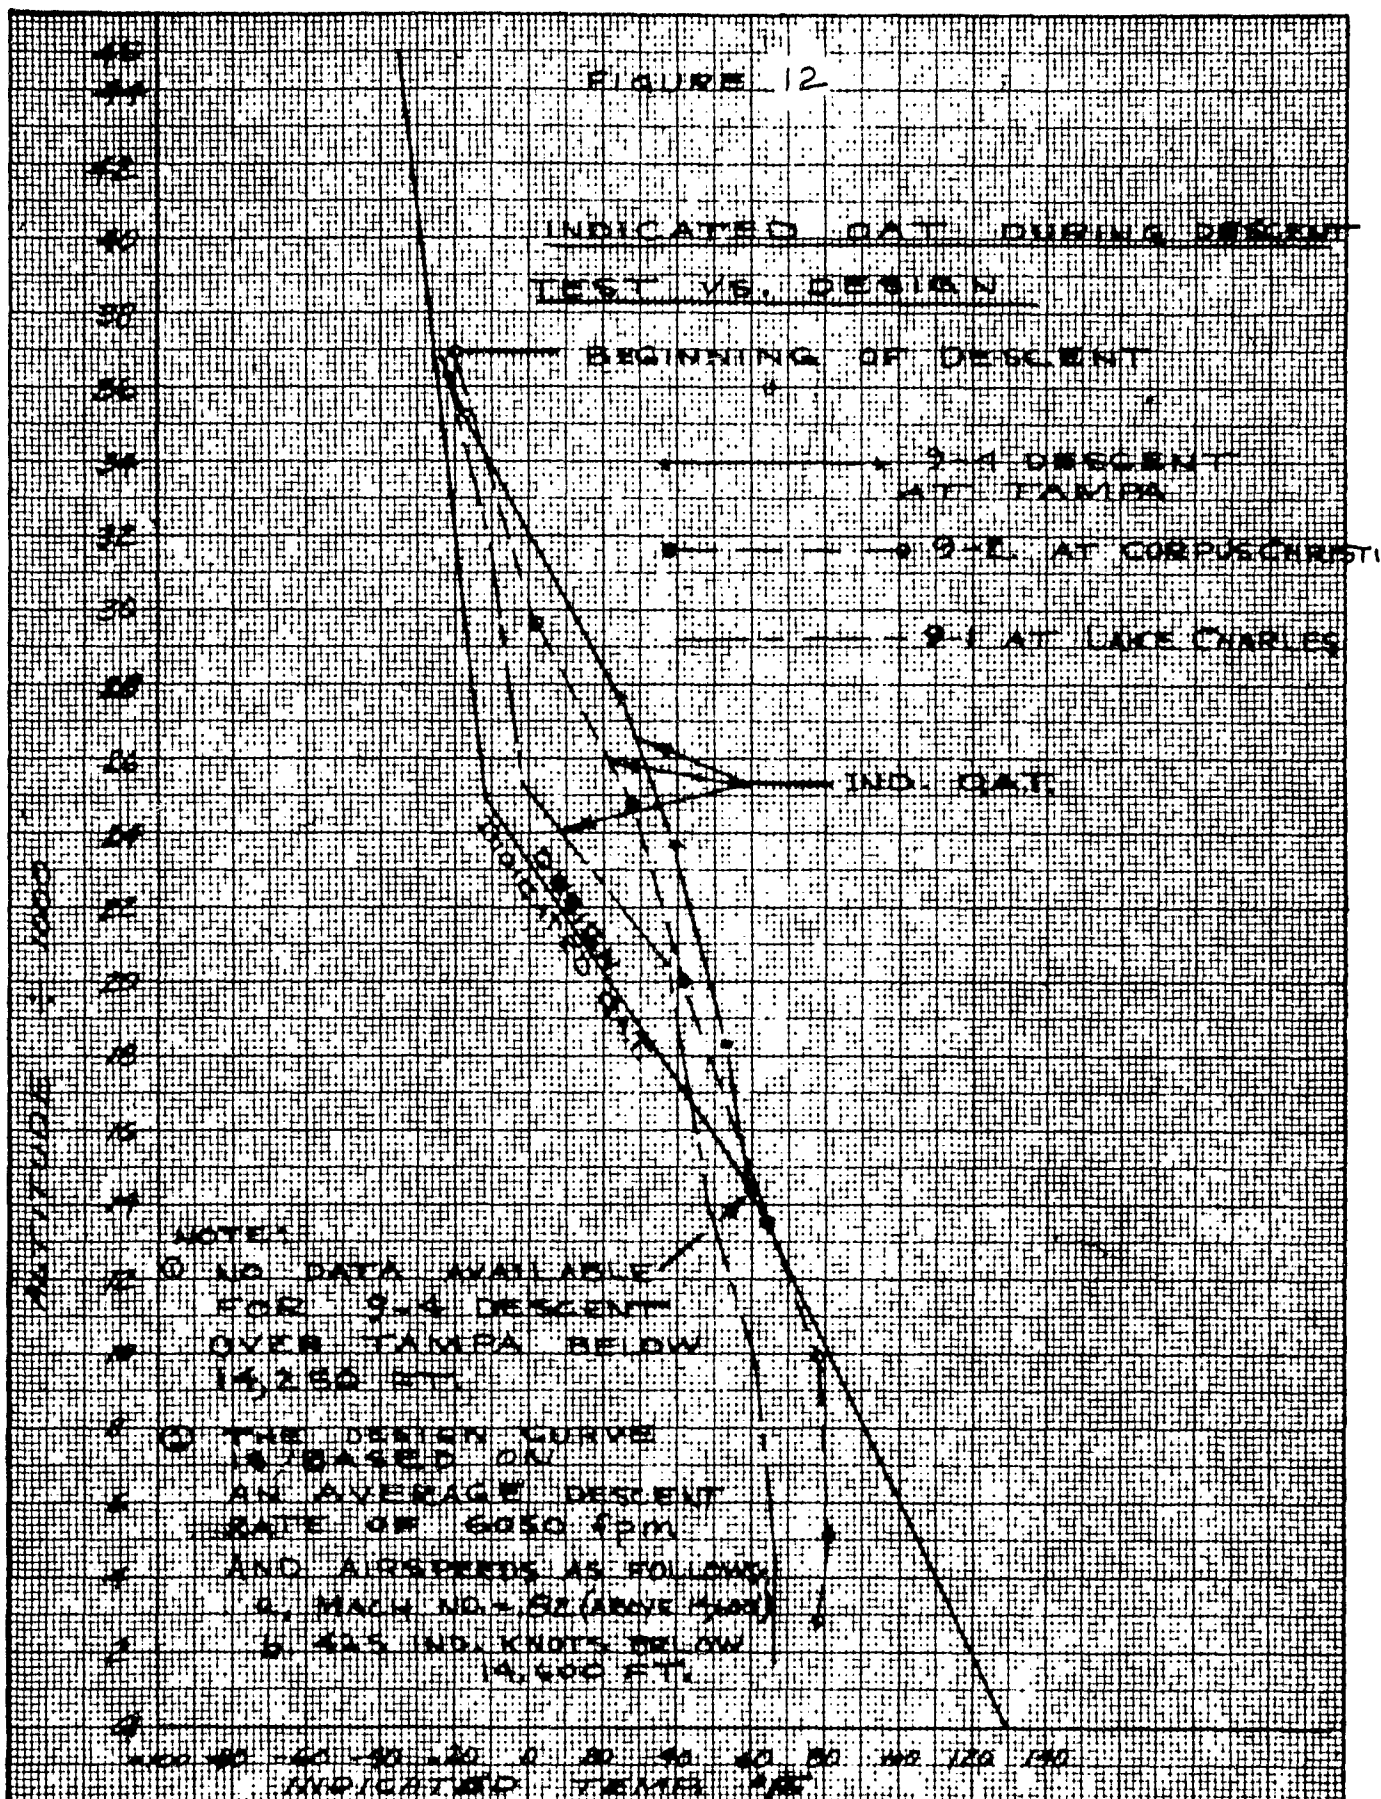
CALC	JER	10-22-53	REVISED	DATE	INDICATED OAT DURING DESCENT TEST VS. DESIGN	FIGURE 12
CHECK						RE-17E
APR						WD-14018
APR						PAGE 62
					BOEING AIRPLANE COMPANY WICHITA 1, KANSAS	OF
CONTRACT NO.

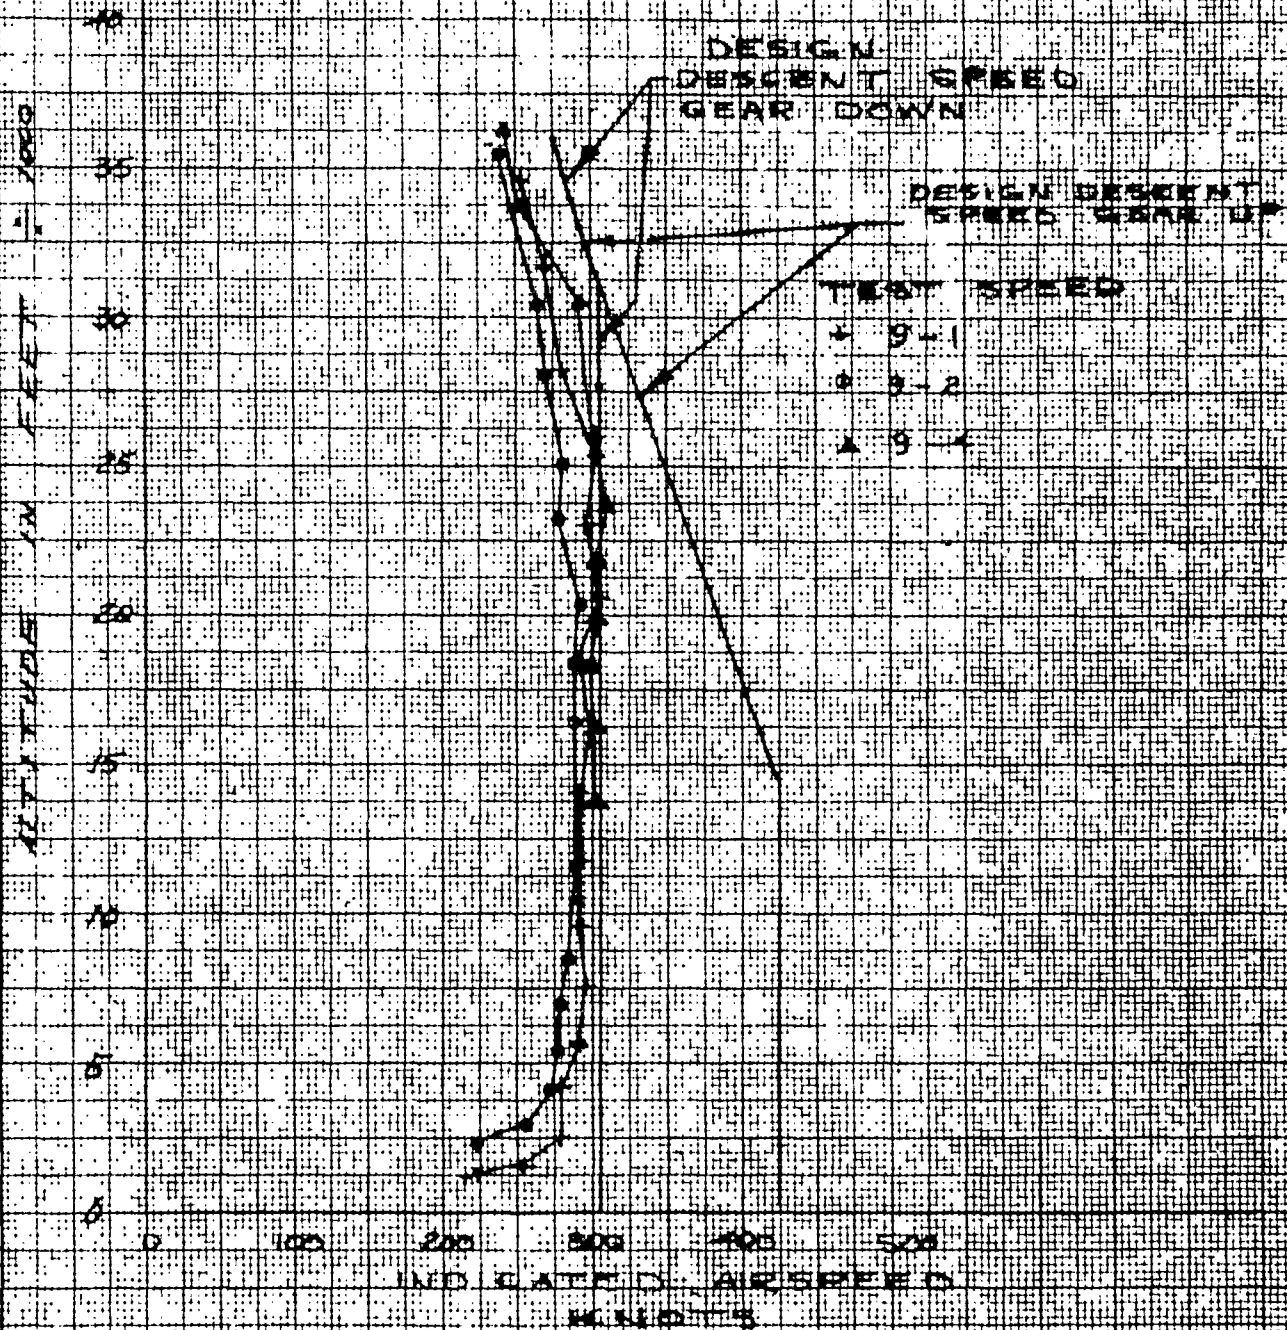
FIGURE  
13  
RB-77E  
WD-14018  
PAGE 13  
OF

DESIGN & TEST DESCENT SPEEDS

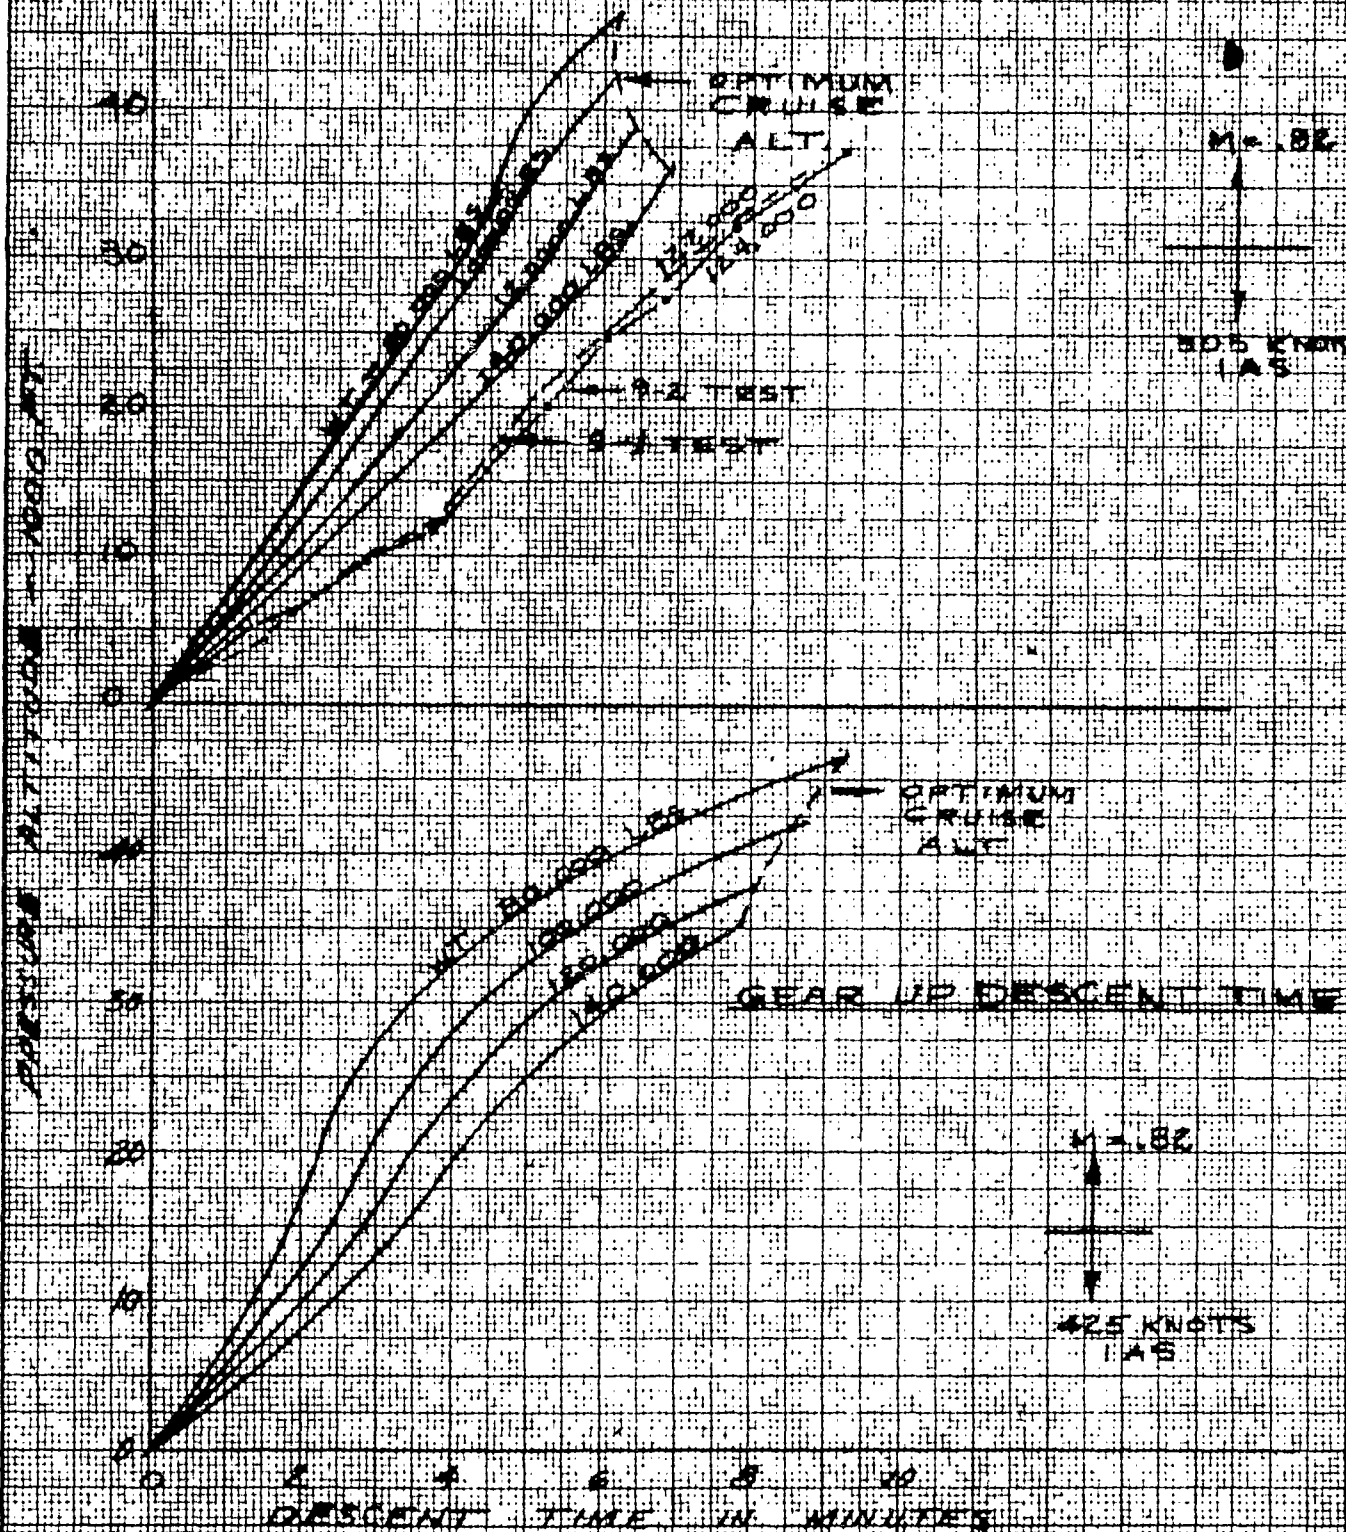
FIGURE  
14  
RB-47E  
WD-14018  
PAGE 64  
OF

DESCENT TIME  
GEAR DOWN

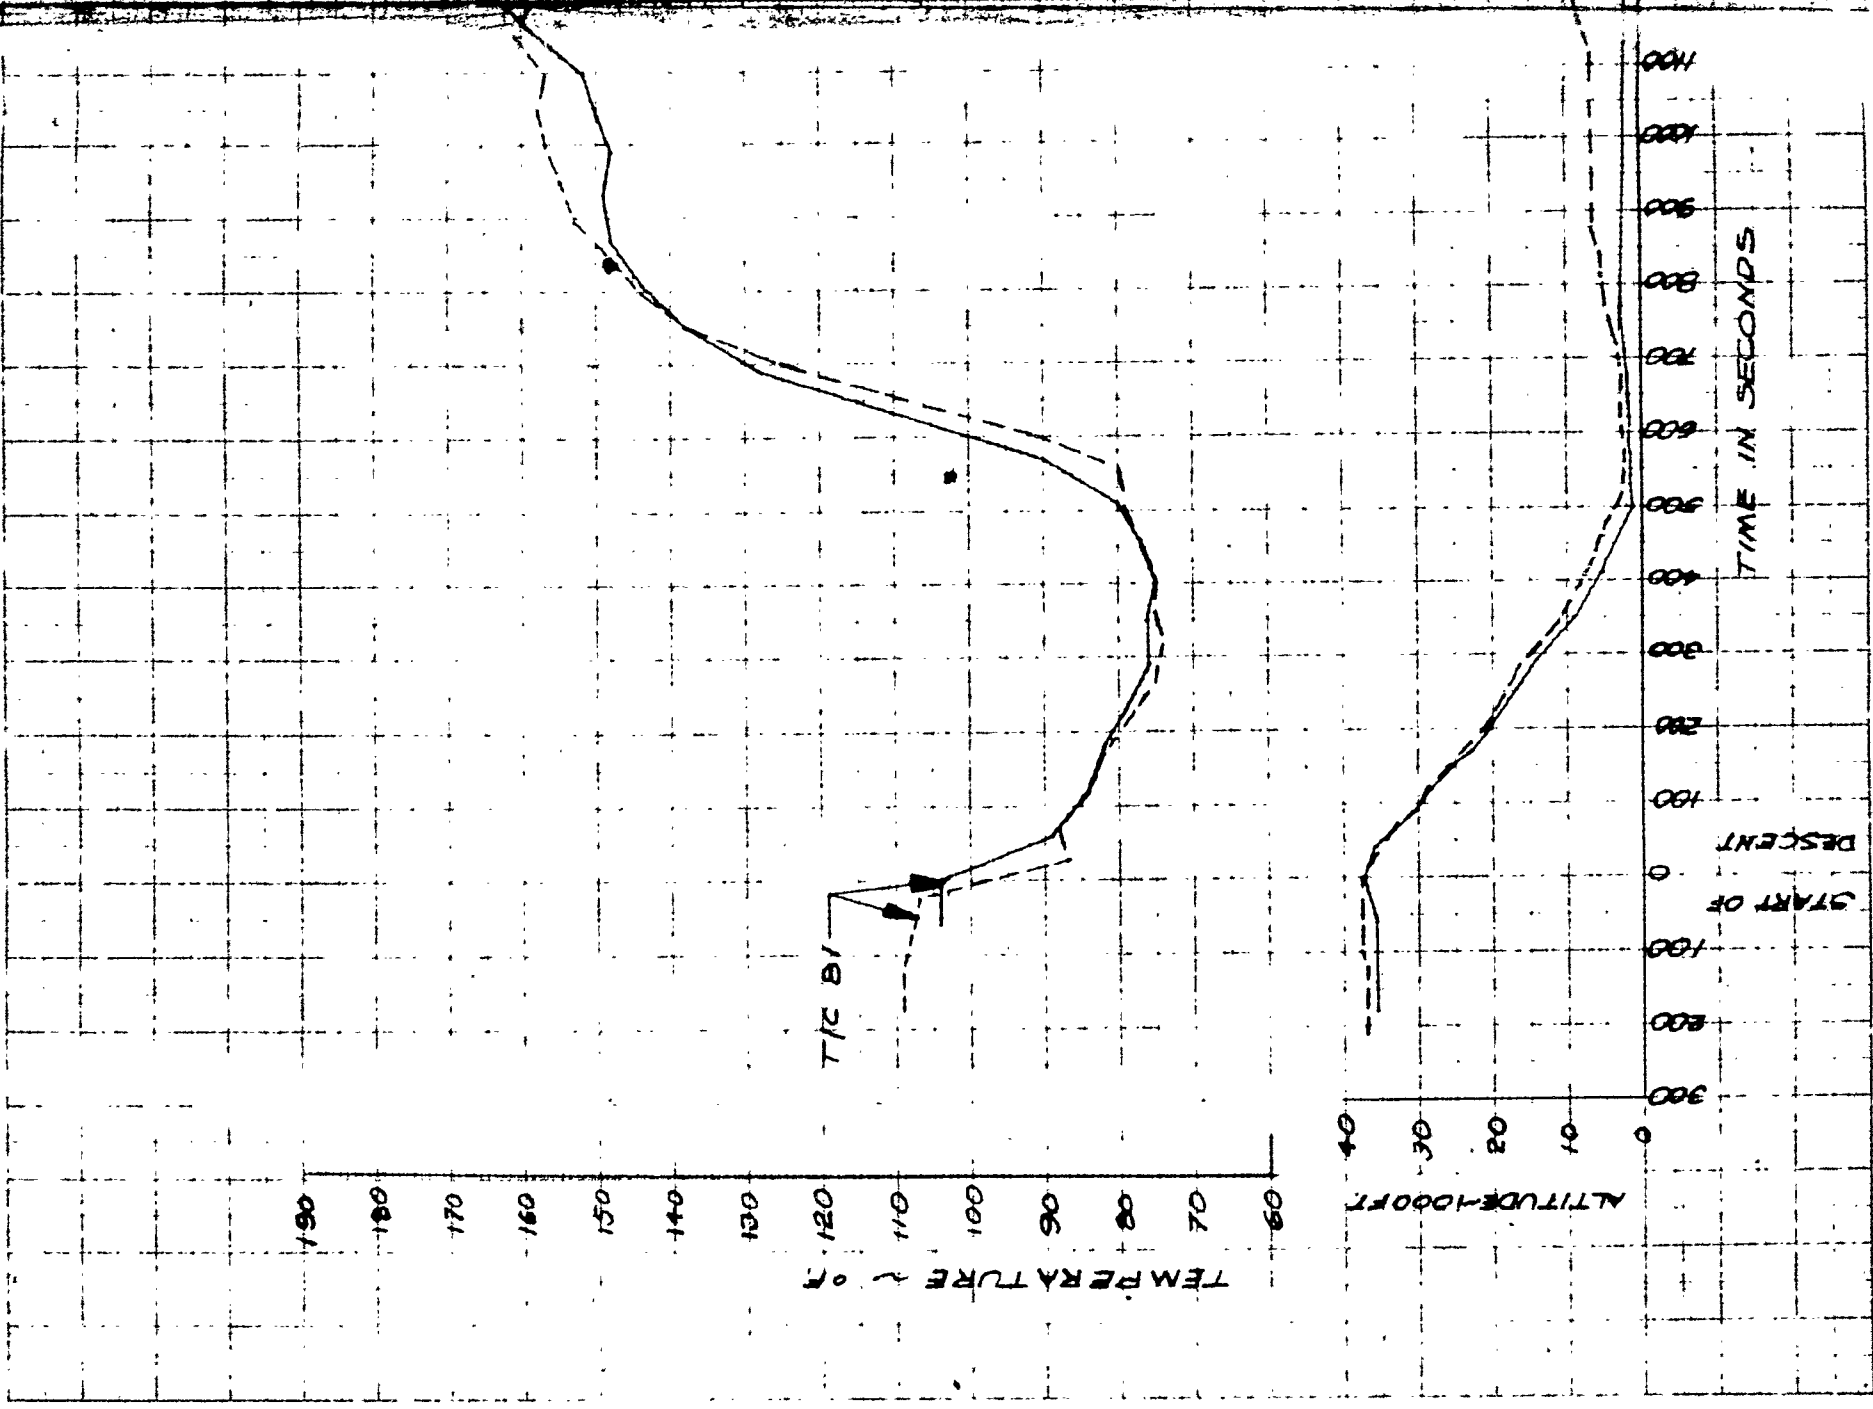
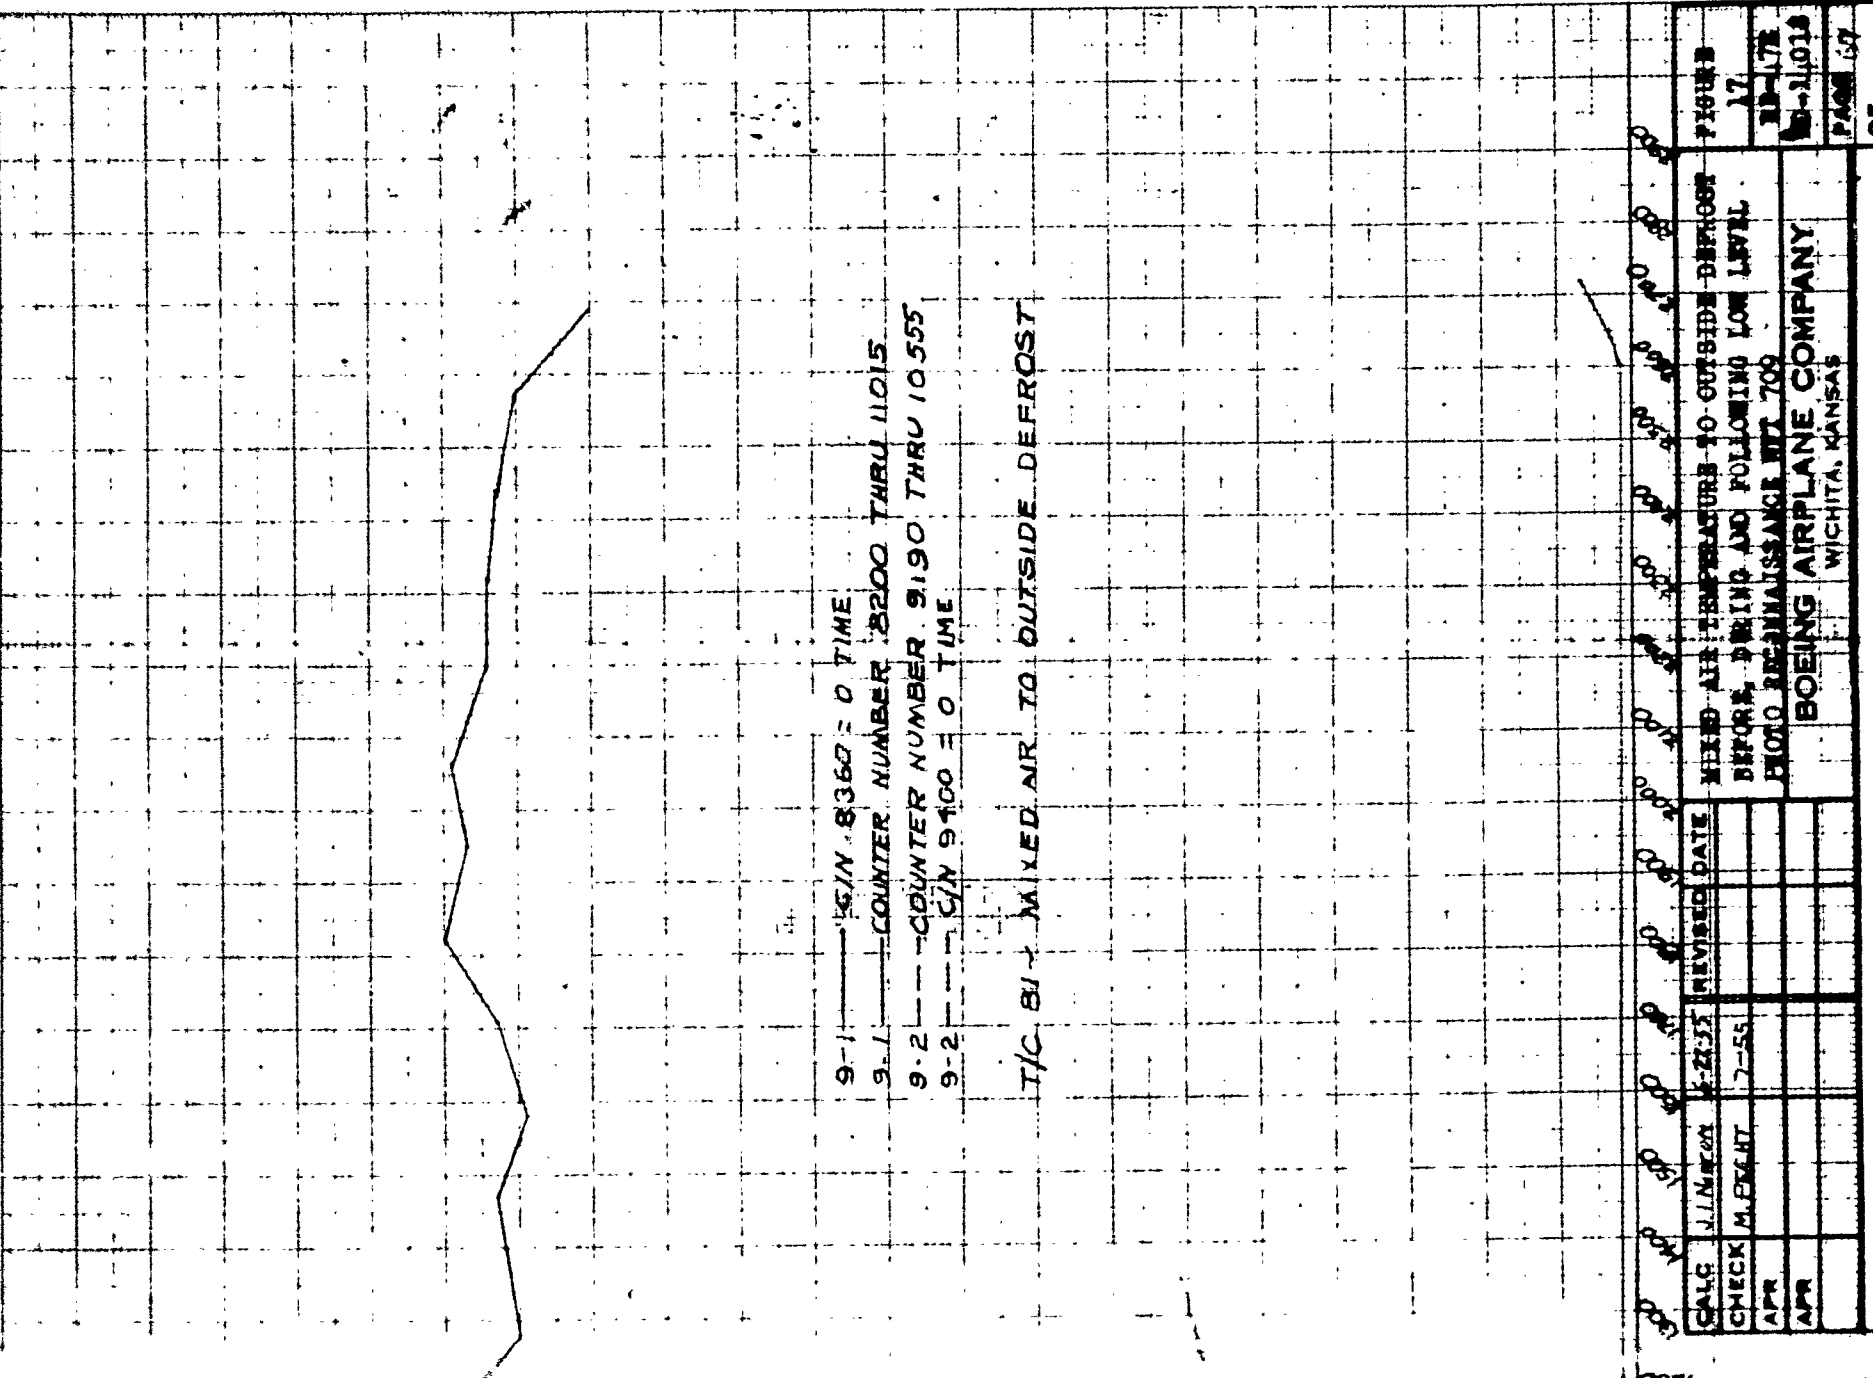
9-1 ---GIN 8360 = 0 TIME  
 9-1 ---COUNTER NUMBER 8200 THRU 11015  
 9-2 ---COUNTER NUMBER 9190 THRU 10555  
 9-2 ---GIN 9400 = 0 TIME  
 T/C BU - MIXED AIR TO OUTSIDE DEFROST

CALC J. J. NIXON	REVISED DATE 6-22-55	MIXED AIR TEMPERATURE TO OUTSIDE DEFROST BEFORE, DURING AND FOLLOWING LOW LEVEL PHOTO RECONNAISSANCE MT 709	FIGURE 17
CHECK M. E. BENT	7-55		ED-LITE
APR		BOEING AIRPLANE COMPANY	WD-31018
APR		WICHITA, KANSAS	PAGE 57
CONTRACT NO.			OF
